TIRE RUBBER IN HOT MIX ASPHALT PAVEMENTS

FINAL REPORT

**WISCONSIN FEDERAL EXPERIMENTAL PROJECT # WI 89-04
and
WISDOT RESEARCH STUDY # 93-01a**

FINAL REPORT # WI-06-02

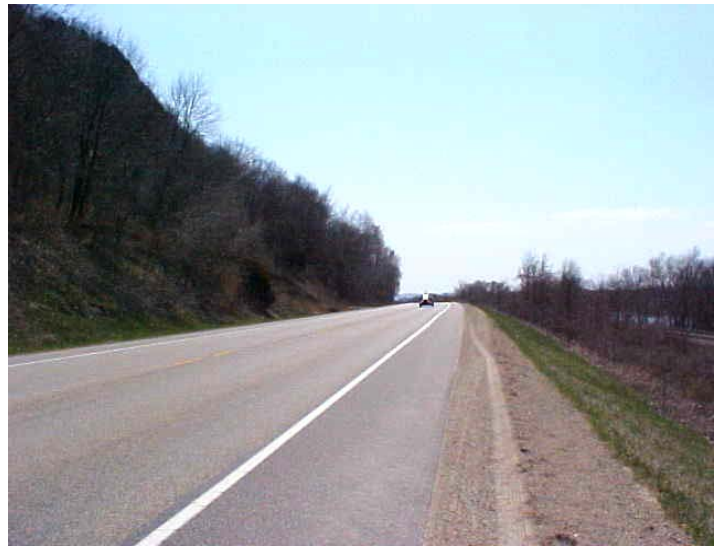
Photograph 1. STH 35 Recycled CRM RAP Project Site

It should be noted that STH 35 is located adjacent to the Mississippi River, with steep embankments on both sides of the highway (see Photograph 1). The steep slopes and highly variable soils (talus material from the bluffs) may contribute to differential movements under extreme conditions, potentially affecting the pavement performance.

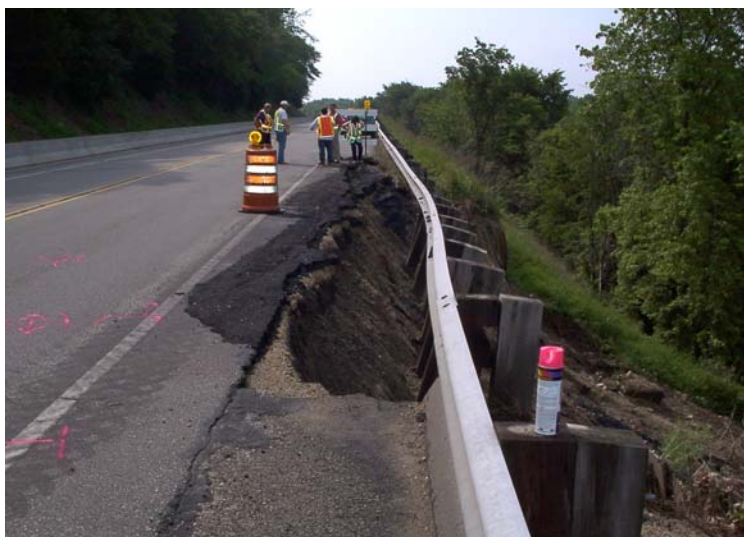
Photograph 2. Slope Failure (South of Recycled CRM RAP Project Site)

In fact, in one extreme case in 2000, a segment of the western slope along STH 35, several miles south of the CRM RAP project site, failed, causing the partial loss of the southbound shoulder (see Photograph 2).

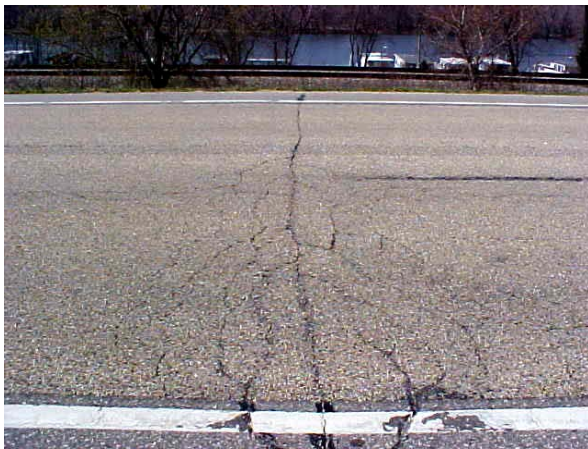
A final site inspection, conducted in April 2004, showed that all four sections had a combination of Type I single (less than ½-inch in width) and Type III banded (multiple cracks in close proximity resulting in a narrow band of cracks) transverse and longitudinal cracks in both the northbound and the southbound lanes (see Photographs 3 & 4 below).

Photograph 3. Type III Banded Transverse Crack in the NB lane and Type I Single Transverse Crack in the SB lane

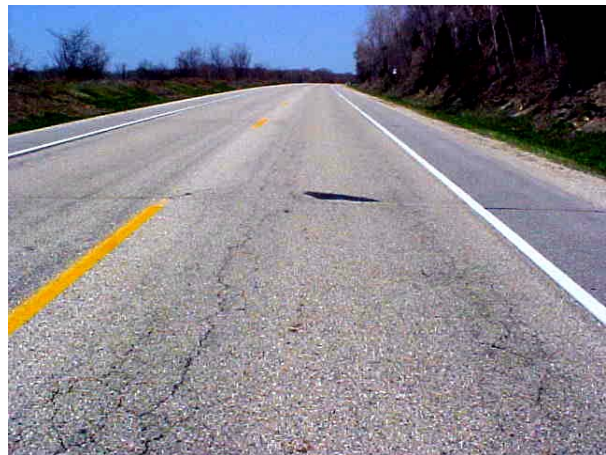
Photograph 4. Type III Banded Longitudinal Crack
